SAFETY ALERT

Title:	Mains Power Installation		
Date:	07/07/2023	Memo Ref	SM745114
Location:	QLD & NSW – Building Supervisors, Electrical Contractors		
Background	<p>An incident occurred recently in NSW where a bricklayer suffered serious injuries when screwing a brick tie that went through the mains power conduit.</p> <p><i>The conduit had no mechanical protection (cover plate) installed.</i></p> <p><u>Please note that the incident did <i>not</i> occur at a Coral Homes site.</u></p>

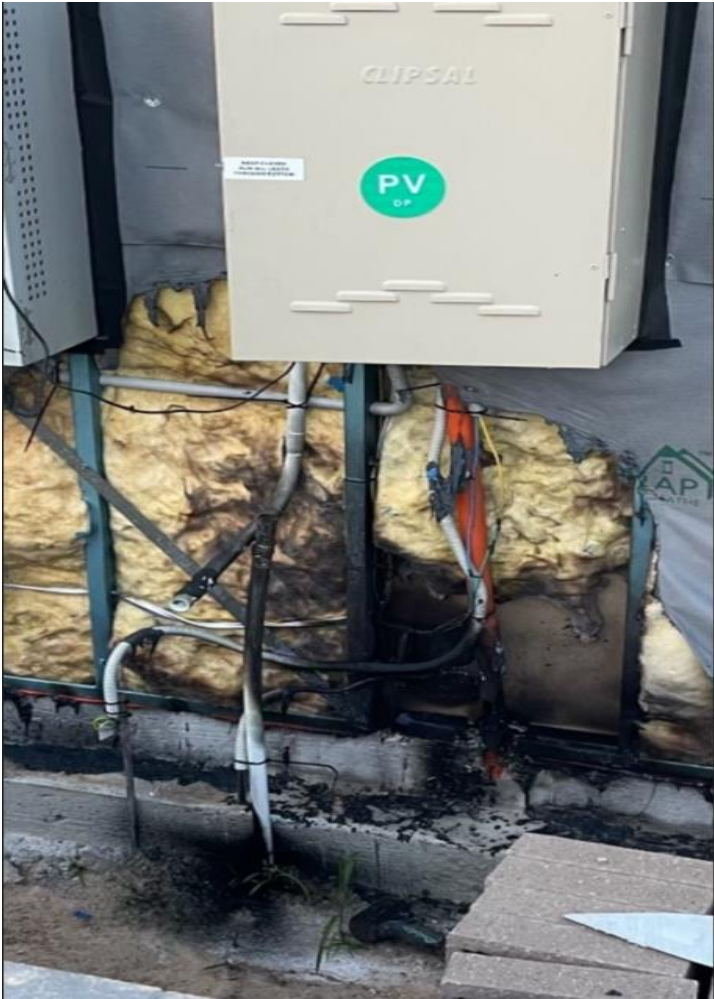
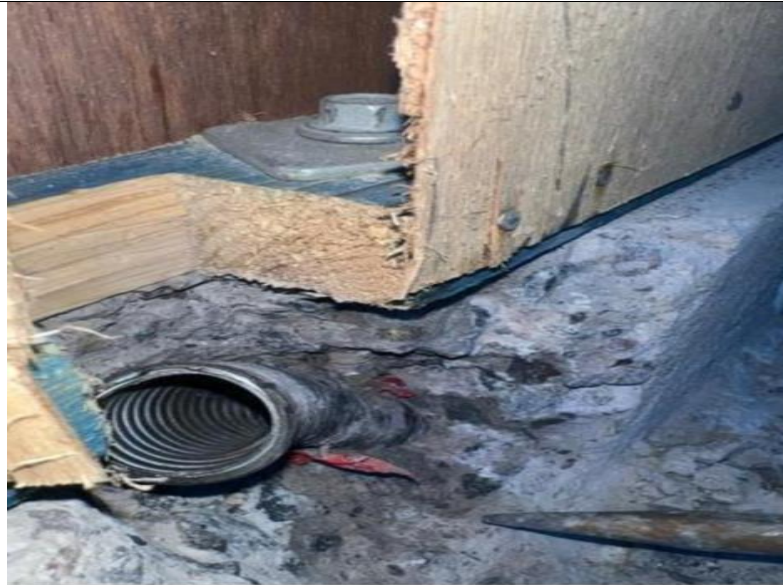
A similar incident has occurred where electrical mains were *not* run directly (vertically) from ground to the electrical board. The conduit was raised into and ran horizontally within the ground slab and was impacted when a carpenter drove a coach screw into the slab when installing framing.

- Protective metal covers are installed over exposed conduit (See photo example below).
- Stickers are installed indicating Live Power (See photo)
- In ground electrical mains power supply is only run directly and vertically from ground to the switchboard.
